Manhole Inspection Summary

Manhole # S250__021MH

Insp Date: **4/2/08 10:53 AM**

Location Address: **1501 Bush St**

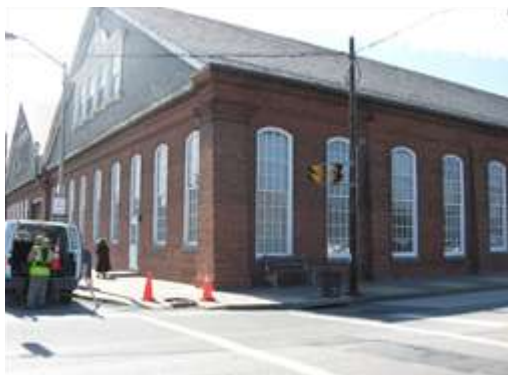
Location View

1501 Bush St

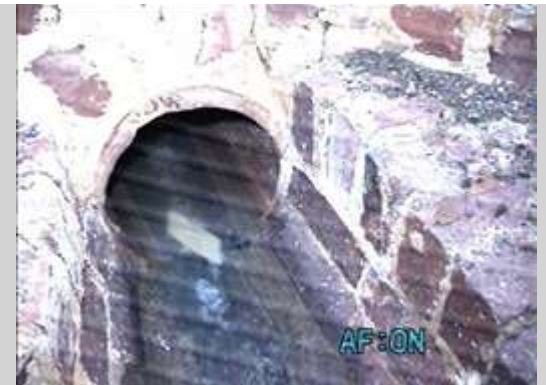
3 O'Clock Inflow

8 in. Circular Gravity Sewer
Pipe In @ 3 O'Clock

Pipe Height: **8.4** (in.) Rod and Bar (Angled)
Pipe Material: **Clay** ☐ Pipe Lined
Invert Depth: **6.90** (ft.) Flow Characteristics: **Slow**
Deposits: ☒ None ☐ Mud ☐ Sludge ☐ Debris ☐ Grease
Silt Depth: **0** (in.) Deposits Extent:
Infiltration: **None** Pipe Seal Cond: **Sound**
